LANGHOLT 3 Teiknúmer:
801 Selfossi 100-02
Hesthús / reiðskemman, mhl. 03

Aðaluppdrættir: Mælikvæði:
Grunnmynd haughúss 1:100
Sniðmyndir og ásýndir 1:100

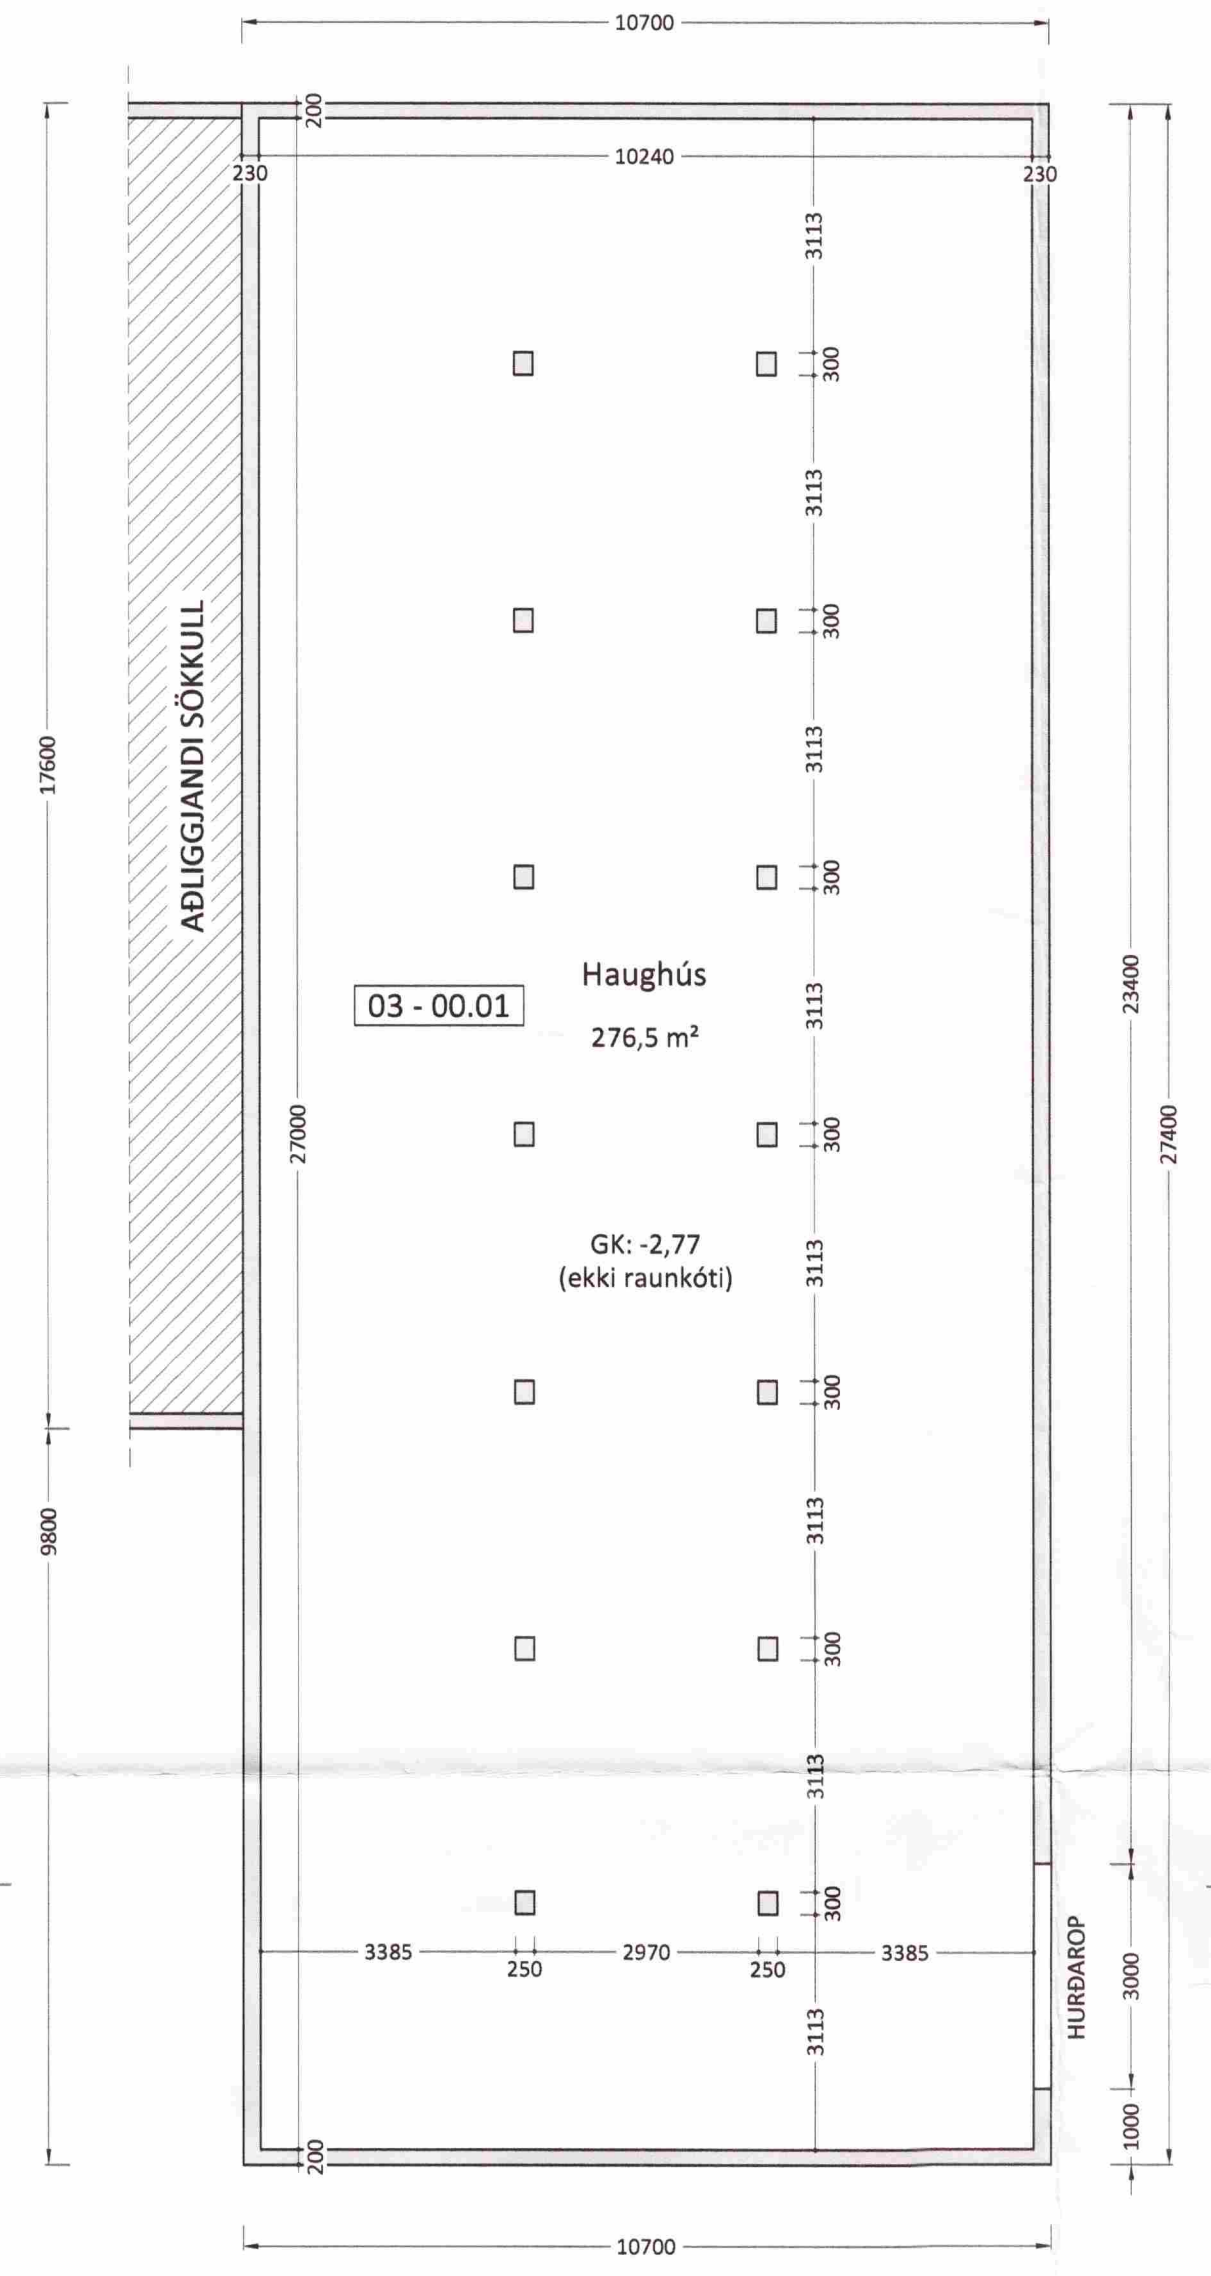
03 - 00.01 Haughús
276,5 m²

GK: -2,77
(ekki raunkóti)
